Corrosion of exposed metal in ash dewatering bins was weakening the structure.

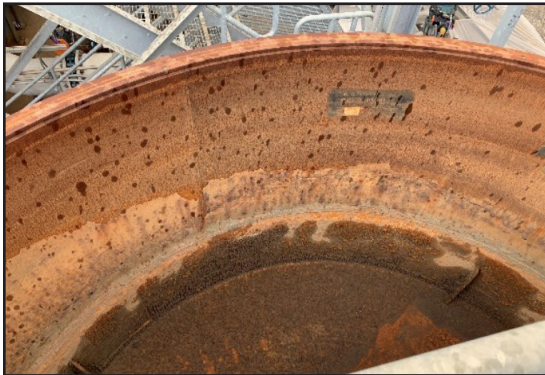
Ash/water mix had low pH and high chlorides which accelerated corrosion losses to >60 mils/year.

Severe corrosion inside tank [or] the bin.

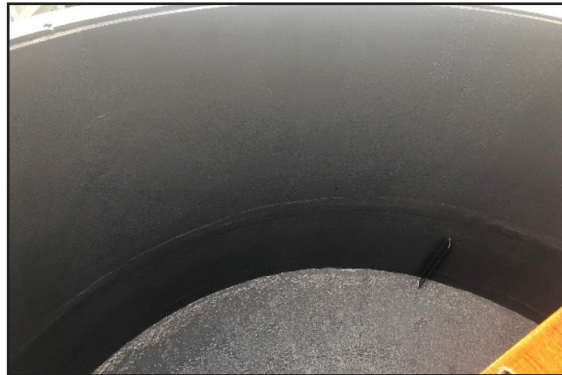
Blasted surfaces being repaired with ARC 858.

Chesterton® ARC 858 was applied to the heavily pitted regions and weld zones where the corrosion was most severe.

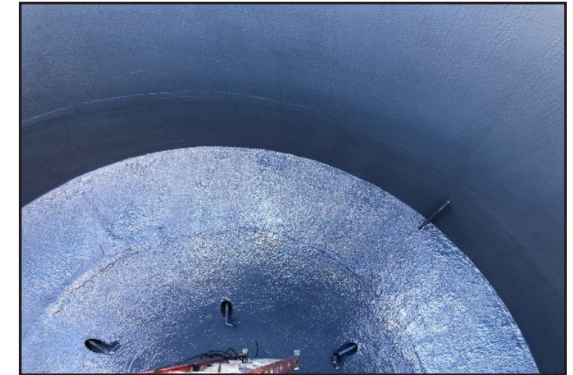
Second of two coats of ARC SD4i after application.

Two successive 10 – 12 mil coats of Chesterton ARC SD4i were applied by brush/roller.
