Challenge

Extreme abrasion and corrosion damage side plate in slurry pump leading to unplanned shut down (costing >€150K) at least once per year.

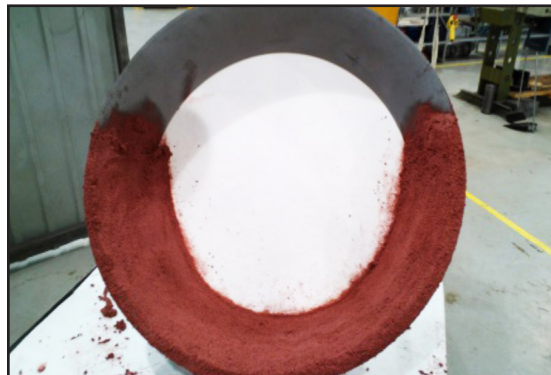
Abrasive gypsum slurry in hot phosphoric acid erodes and abrades alloy side plate.

Side plate during ARC T7 AR application.

- Machine side plate to 6 mm to allow for clearance to apply product
- Grit blast using aluminum oxide to Sa 2.5 with 3-5 mil (75-125 µm) profile

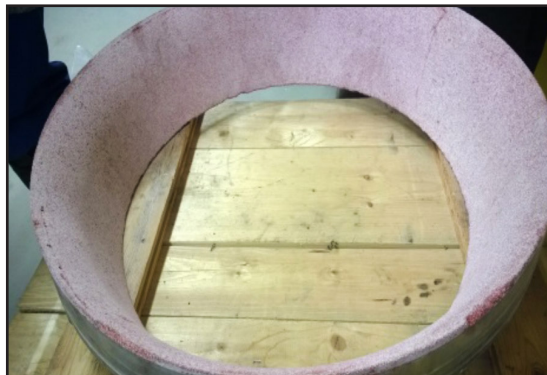
Side plate after machining the ARC T7 AR.

1. Apply 7 mm (275 mil) of ARC T7 AR to side plate
2. Machine side plate to tolerance with diamond bit

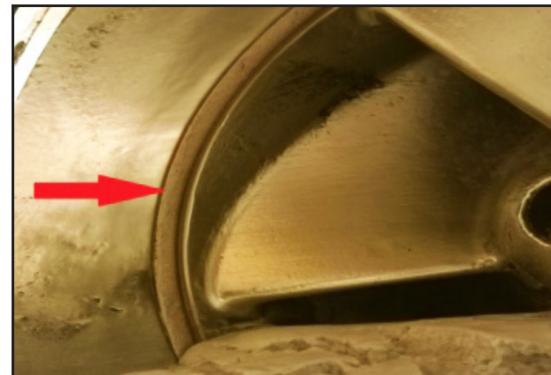
- After continuous operation for >1,400 hours the ARC T7 AR coated side plate has lost < 0.5 mm total thickness. Client projects coating to last at least a year, doubling service life.
- Client plans to recoat side plate every 12 months

No loss of tolerance between impeller and side plate protected with ARC T7 AR.
