Challenge

Background

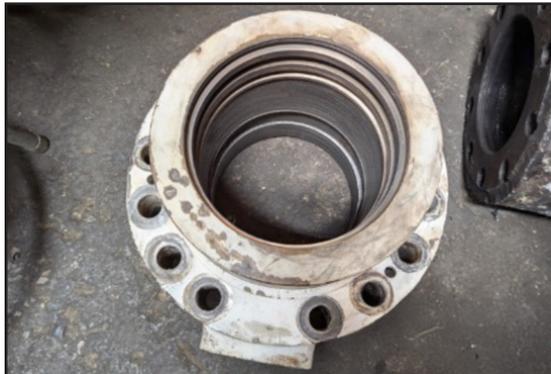
A customer received an opportunity to repair a large mining shovel cylinder. Upon further inspection, the customer noted that the wiper groove had been modified from its original dimensional specifications to a larger size. The head gland was inspected and deemed reusable; however, an OEM seal kit could not be used. The customer's only option was to replace the gland with a new gland at the cost of \$30K, jeopardizing their bid to capture the end user's repair business.

Head gland.

A Chesterton specialist measured the cylinder and provided a custom seal kit including a **Chesterton® 21K Wiper Seal** made from **AWC860 high temperature polyurethane** material machined to the customer's exact equipment dimensions.

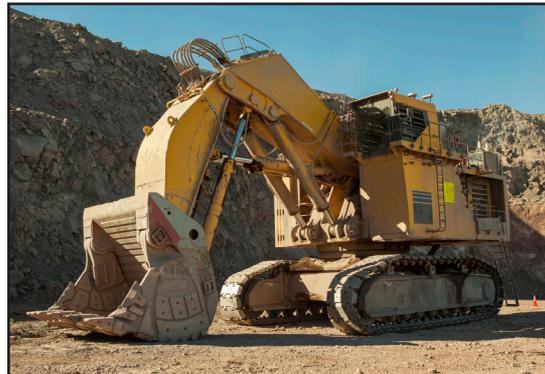
Mining shovel with cylinder in need of repairs.

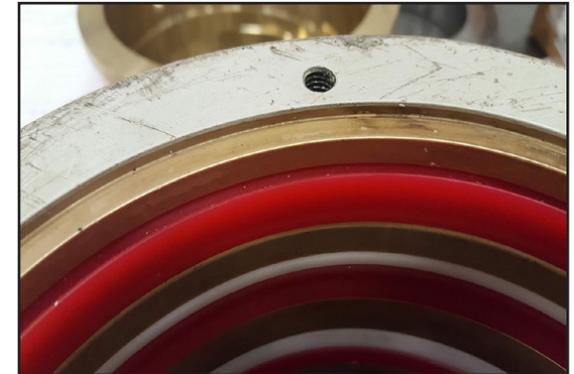
Chesterton 21K Wiper Seal.
