Challenge

Damaged expansion joints at snack foods manufacturer's warehouse were becoming a safety issue for forklifts. The worn joints caused forklifts to spill loads as well as damaging the wheels of the forklift.

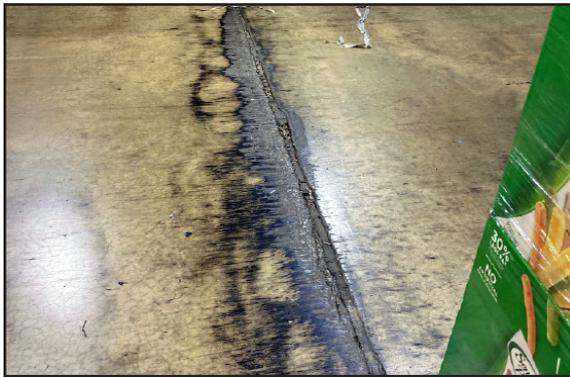
Heavy loads and movement at the expansion joint allowed for the wheels on the forklift to start breaking up concrete as the forklift moved from one slab to the other.

Damaged expansion joint.

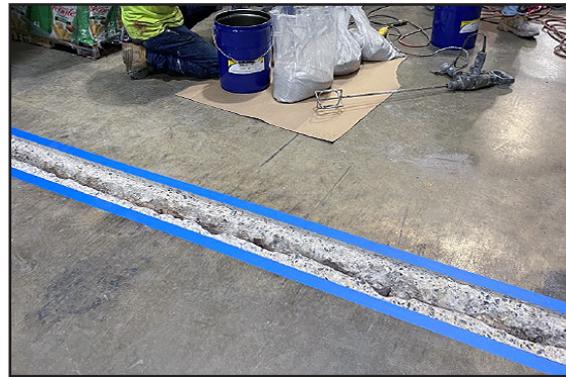
Damaged joint prepared for repairs with EG-1 FC patch kits.

Key cuts were made 6" back on either side of the expansion joint. The loose concrete was removed by chipping hammers.

Chesterton® EG-1 FC patch kits were utilized for ease of mixing for the contractor.

EG-1 FC patch kits were also used by the contractor to cut new expansion joints in just a few hours, which could not have been done with standard cure patch kits.

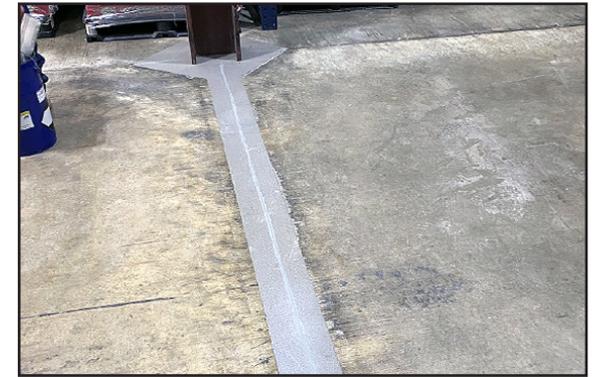
Repairs allowed area to be back in service in <4 hours.

Expansion joints are now safer to travel over as well as reducing damage to forklifts.
