Challenge

Catalyst pumps required frequent repair resulting in system shutdowns.

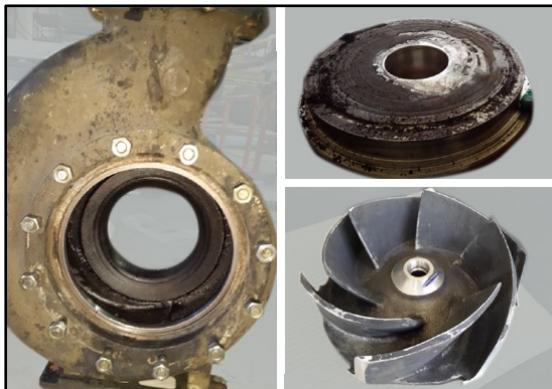
Catalyst particle size reduction from 20 to 5 μm due to reduce clearance in pumps. High temperatures and the chemical scale build-up on wetted edge of pump resulted in increased amperage and energy.

Before: Pump and back plate showing scaling, impeller is new.

Catalyst residue was removed followed by grit blasting to Sa 2.5 cleanliness with 75+ micron profile.

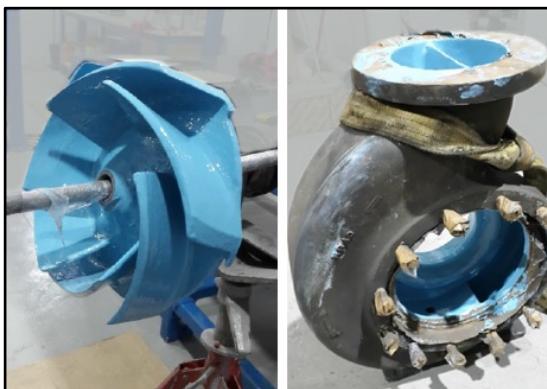
Three alternating color coats (Gray, Blue, Gray) of ARC HT-S were manually applied by brush to a total DFT of 800 – 1000 microns (31 – 40 mils).

In process: manual apply three coats of ARC HT-S.

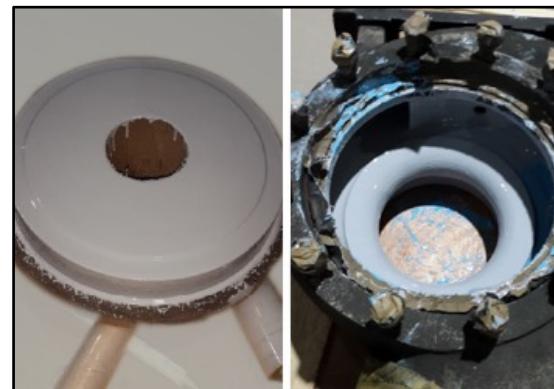
After: Finished pump components, before assembly.

After six months in service, client stated there was no damage to coating. Over the six months run time, there was no increase in motor amperage demand indicating that clearances were maintained. Client is extremely satisfied with ARC solution and decided to coat remaining five catalyst pumps in process.
