## Challenge

Slurry thickener at a major South American mine

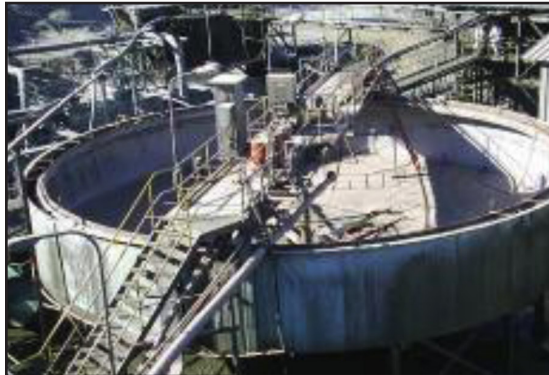
Previously applied coal tar coatings failed prematurely at 2 years resulting in unanticipated floor corrosion. Corrosion protection of 6 years required for maintenance cycle.

Thickener solution, containing sulfates, chlorides, and abrasive slurry, attacks unprotected steel.

- Grit blast remove old coal tar epoxy
- Grit blast to Sa 2.5 with 3 mil (75 µm) profile

1. Apply **ARC S2** stripe coat to weld seams
2. Apply 2 coats of **ARC S2** @ 15-20 mils (375-500 µm)/coat

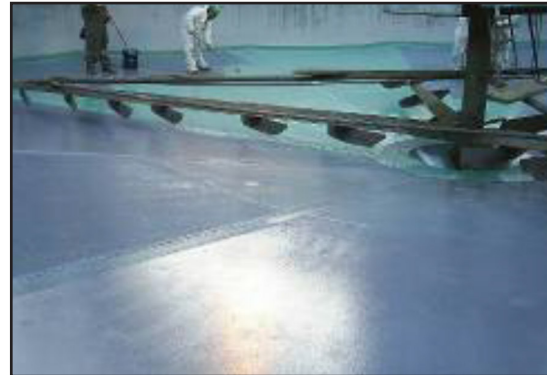
Alternating colors of ARC S2

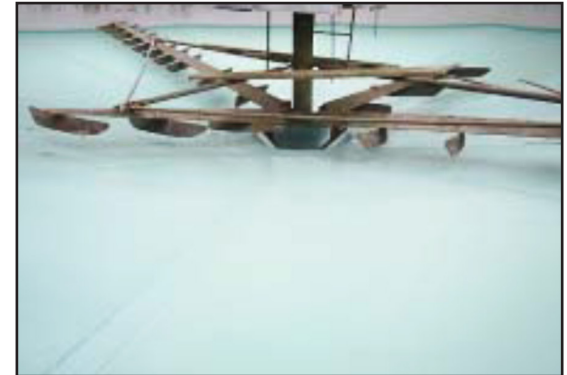
- ARC coating providing >6 years service life (3X of coal tar solution)
- Elimination of 2 thickener clean outs provide additional savings

ARC S2 still in excellent condition
