Superior Sealing Technology Adds Efficiency to Refurbished Hydro Turbine

Hydropower Industry
Chesterton 442 and 14K Restrictor Bushing
Mechanical Seal and Polymer Seal Case Study

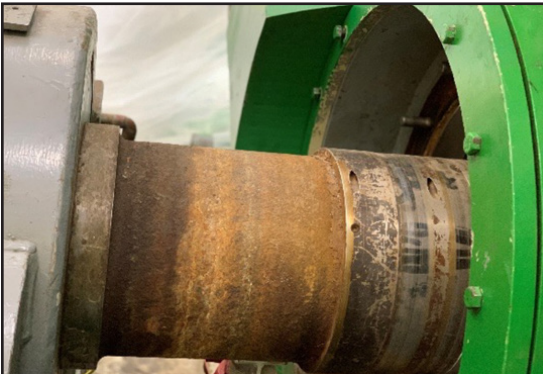
Original packing box was leaking.

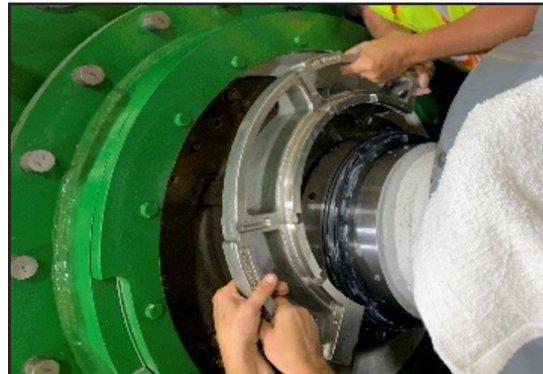
The 442 Split Seal was adapted to fit the stuffing box.

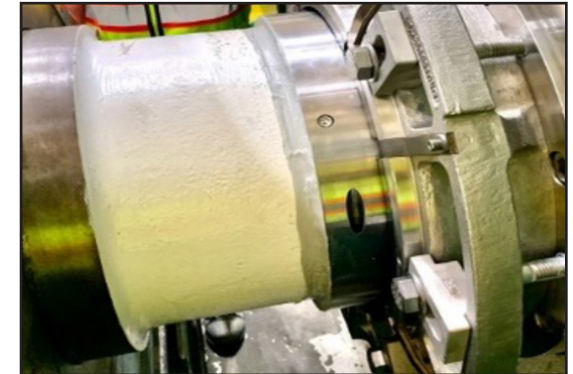
Installed equipment is running effectively.
